Collision mat

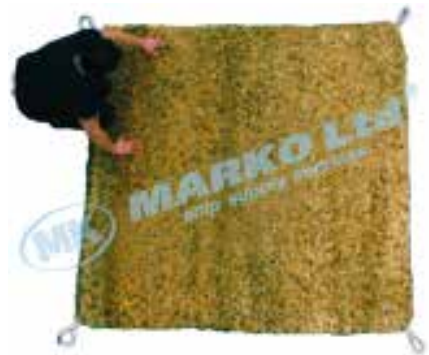
Emergency collision mat is used to patch damages or hull breaches with sharp uneven edges. The backbone is a mat, thrummed with a pitch line with a circumference of 75 mm and two layers of stitched canvas patch. The thrum is made of sisal rope-yarn. The patch is laid to the breach with the side on which the thrummed mat is sewn.

The collision mat is planted using pulley hoists with a lifting capacity of 1 ton (2 sets).

Delivery set: protective cover, iron cramps, snatch blocks, lowering lines, keel hauling lines, swiveling pulley hoists with can hooks.

- Size - 2.0 x 2.0 m;
- Canvas layers - 2 pcs.;
- Interlayer - 1 pad;
